Reflective Cracking Testing Notes

Date: March 08, 2017

Project: Reflective Cracking Indoor Phase 5

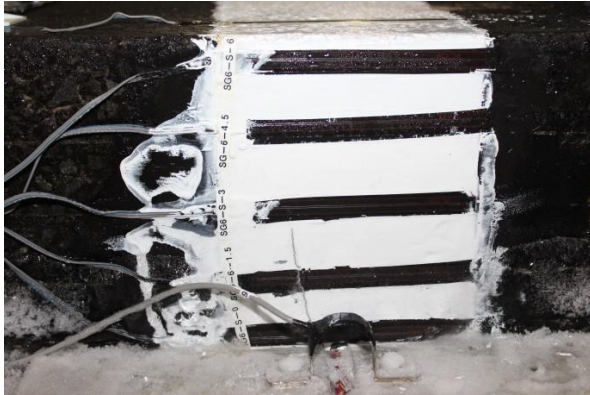
- Outer vertical edge:
 - Crack through SG6-S-0 and SG6-S-1.5. Crack at SG6-S-3 as shown in Figure 1.
 - Visual observation is the same as yesterday.
- Joint surface area:
 - None of the surface gauges show evidence of a crack.
 - Visual observation is the same as yesterday.
- Inner vertical edge:
 - None of the inner vertical edge gauges show evidence of a crack.
 - Visual observation is the same as yesterday.

Figure 1. Crack through SG6-S-0 and SG6-S-1.5. No crack on SG6-S-3, SG6-S-4.5 and SG6-S-6

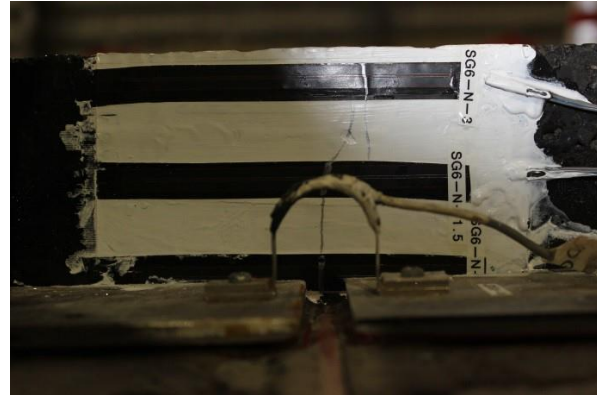
Figure 2. SG6-N-0, SG6-N-1.5 and SG6-N-3. Crack completed

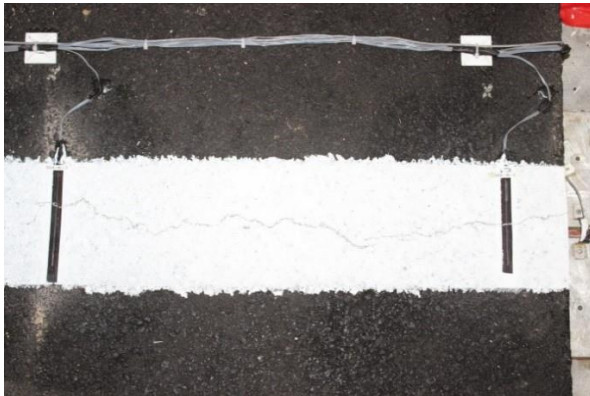
- Outer vertical edge:
 - The vertical edge is completely cracked, SG6-N-0, SG6-N-1.5 and SG6-N-3 as shown in Figure 2.
 - Visual observation is the same as yesterday.
- Joint surface area:
 - Surface crack is more noticeable through SG5-N-3, SG4-N-3 and SG3-N-3 as shown in Figures 3 and 4.
 - Crack propagated 9" from yesterday. (37.5" yesterday; 46.5" today). As shown in Figure 5.
 - No crack on SG2-N-3 as shown in Figure 5.
- Inner vertical edge:
 - No crack on the inner vertical edge.
 - Visual observation is the same as yesterday.

Figure 3. Crack from vertical edge through and SG5-N-3

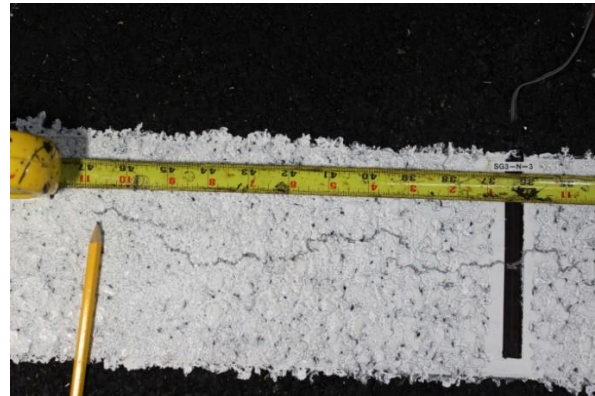
Figure 4. Crack propagated through SG3-N-3 reached up to 46.5".

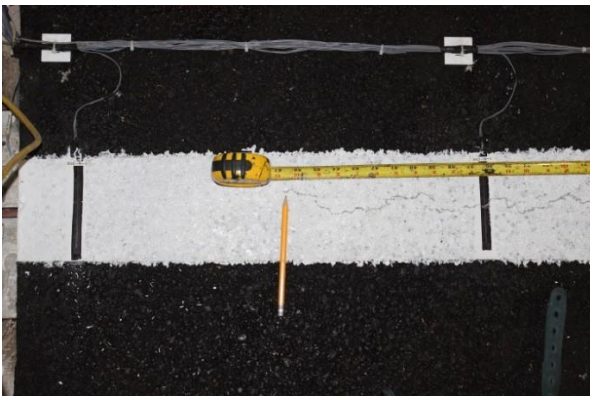
Figure 5. SG-2-N-3 and the inner vertical edge have no cracks
